REPORT NO. 3540  
UNION PACIFIC RAILROAD COMPANY  
IN RE ACCIDENT  
AT SPENCER, IDAHO, ON  
SEPTEMBER 19, 1953

Accident at Spencer, Idaho, on September 19, 1953, caused  
by a motor-truck occupying a rail-highway grade  
crossing immediately in front of an approaching engine  
with cars.

Report No. 3540  
 Union Pacific Railroad  
 Spencer, Idaho  
 September 19, 1953

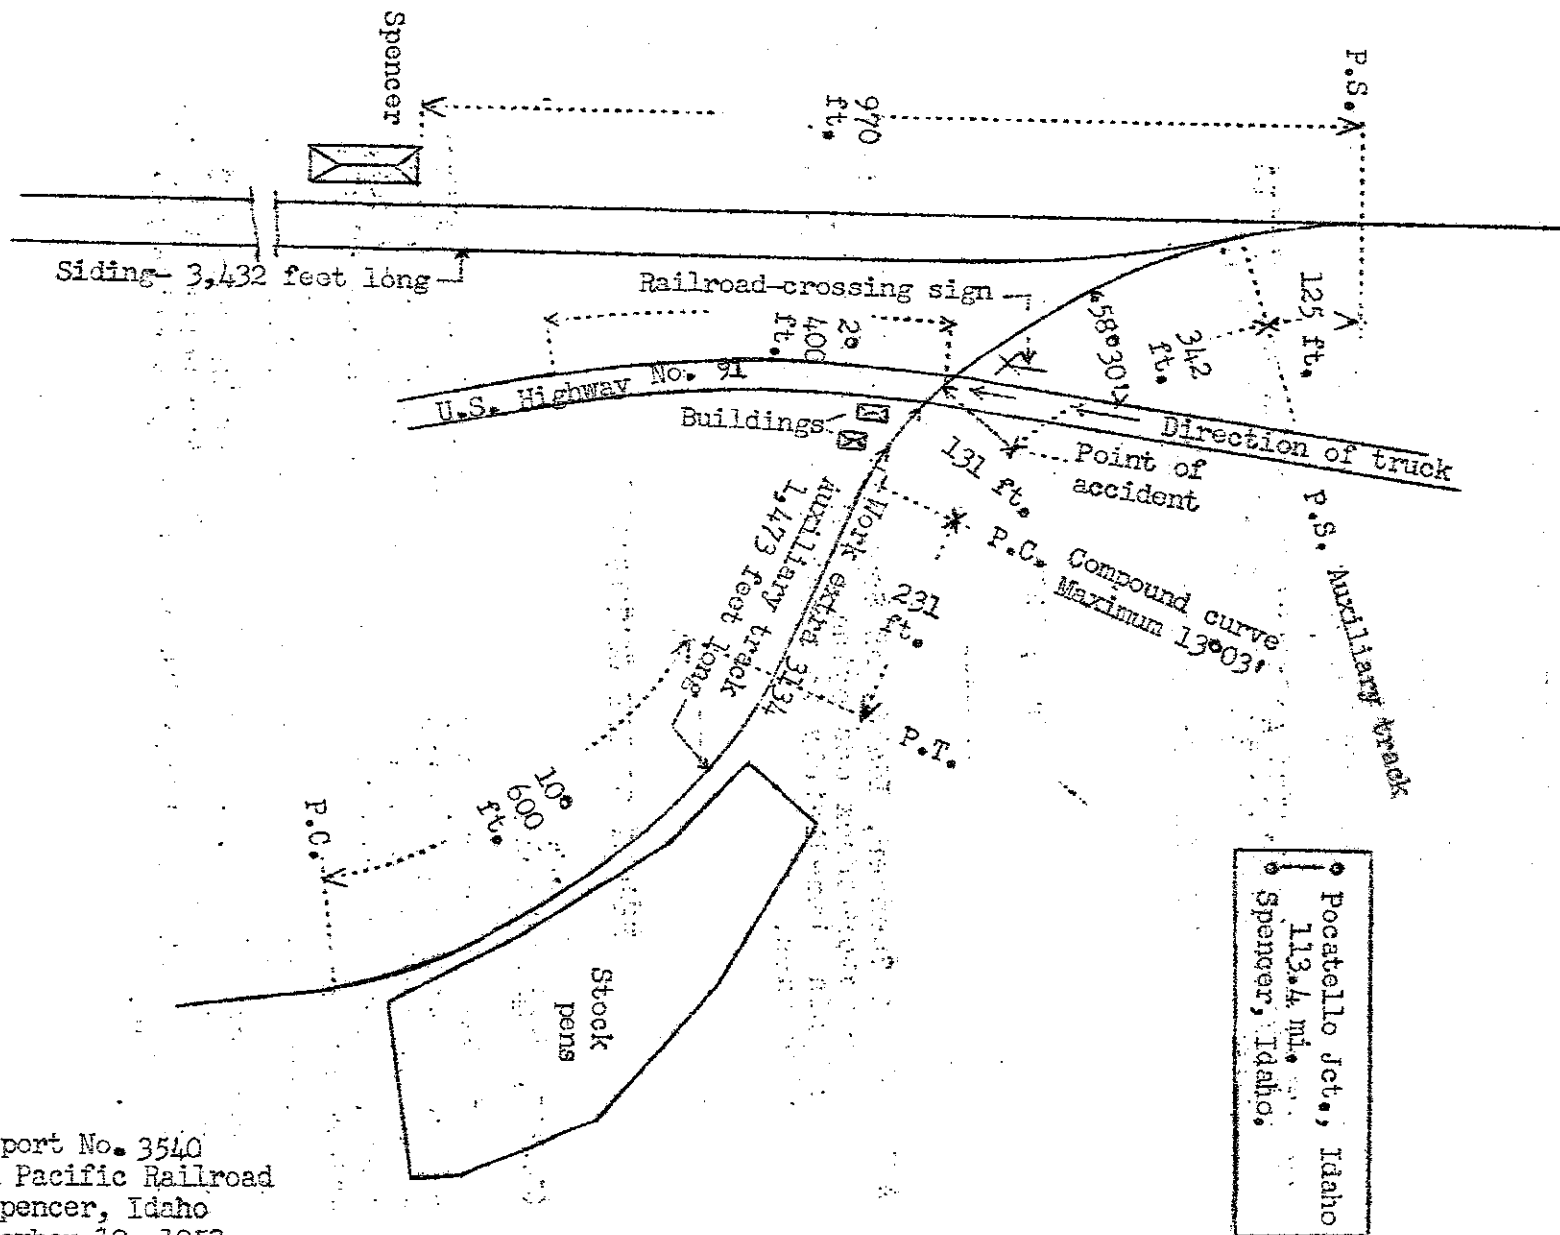
This accident occurred on that part of the Idaho Division extending between Spencer and Pocatello Jct., Idaho, 113.4 miles. In the vicinity of the point of accident this is a single-track line, over which trains are operated by timetable, train orders and an automatic block-signal system. At Spencer, 113.4 miles west of Pocatello Jct., a siding 3,432 feet in length parallels the main track on the south. The railroad at this point extends approximately north and south. Timetable directions on the railroad are east and west, and are used in this report. The east siding-switch at Spencer is located 970 feet east of the station. An auxiliary track 1,473 feet in length extends in a generally southwesterly direction from the siding to stock pens and loading chutes located south of U. S. Highway No. 91. The switch of the auxiliary track is located in the siding at a point 125 feet west of the east siding-switch. It is trailing-point for east-bound movements. The accident occurred on the auxiliary track at a point 342 feet west of the switch, where this track is crossed at grade by U. S. Highway No. 91. The main track is tangent in the vicinity of the east siding-switch. From the west on the auxiliary track there are, in succession, a  $10^\circ$  curve to the left 600 feet in length, a tangent 231 feet and a compound curve to the right, having a maximum curvature of  $13^\circ 03'$ , 131 feet to the point of accident and 342 feet eastward to the siding. The grade for east-bound movements on the auxiliary track is, successively, 2.0 percent descending from the end of the track to the crossing, a vertical curve over the crossing at the point where the accident occurred and then 1.0 percent ascending 300 feet to the siding.

U. S. Highway No. 91 intersects the auxiliary track at an angle of  $58^\circ 30'$ . This highway is 20 feet wide and is surfaced with bituminous material. The crossing is surfaced with bituminous material to the level of the tops of the rails. The highway is tangent throughout a distance of 915 feet immediately east of the crossing and then there is a  $2^\circ$  curve to the left which extends westward from that point a distance of approximately 400 feet. The grade for west-bound vehicles approaching the crossing is, successively, 3.50 percent descending a distance of 700 feet, 1.0 percent ascending 200 feet and practically level over the crossing.

A standard cross-buck railroad-crossing sign is located to the right of the direction of west-bound highway traffic, 22 feet north of the center-line of the highway and 13 feet 6 inches south of the center-line of the auxiliary track. It bears the words "RAILROAD CROSSING" in black on a white background.
